NASA Technical Memorandum 78796

THE EFFECT OF IMPACT DAMAGE AND CIRCULAR  
HOLES ON THE COMPRESSIVE STRENGTH OF A  
GRAPHITE-EPOXY LAMINATE

James H. Starnes, Jr., Marvin D. Rhodes and  
Jerry G. Williams

October 1978

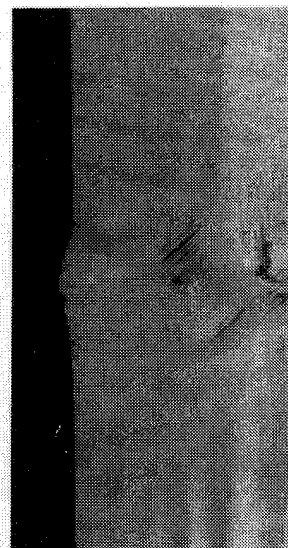
(a) 48 percent of residual strength.

(b) 61 percent of residual strength.

(c) 98 percent of residual strength.

(d) Failed specimen.

Figure 9. - Moire-fringe patterns during residual-strength test of an impact damaged specimen.

Photographs of successive moire-fringe patterns from the residual strength test of specimen N7 are shown in figure 9. Specimen N7 was impacted at 91 m/s with no applied axial load. The photograph in figure 9a shows the moire-fringe pattern of the damaged region at 48 percent of the specimen residual strength. The small light colored circular region in the center of the specimen is the impact site which is beginning to deform out-of-plane. This deformation is the first observable response of the damaged region to the applied axial load. Subsequent moire-fringe patterns (figs. 9b and 9c) represent local buckling of the impact-damaged region that grows laterally as the applied load is increased. The photograph in figure 9d shows the failed specimen with the damage propagated laterally across the specimen in the same manner as the example shown in figure 7. Examination of the failed specimen removed from the test fixture confirmed that the damage propagated laterally and was confined axially to the region indicated in figure 9d.
